**RICHELIEU RIVER BASIN
STOWE, VERMONT**

**LAKE MANSFIELD DAM
VT 00100**

**PHASE I INSPECTION REPORT
NATIONAL DAM INSPECTION PROGRAM**

MARCH, 1979

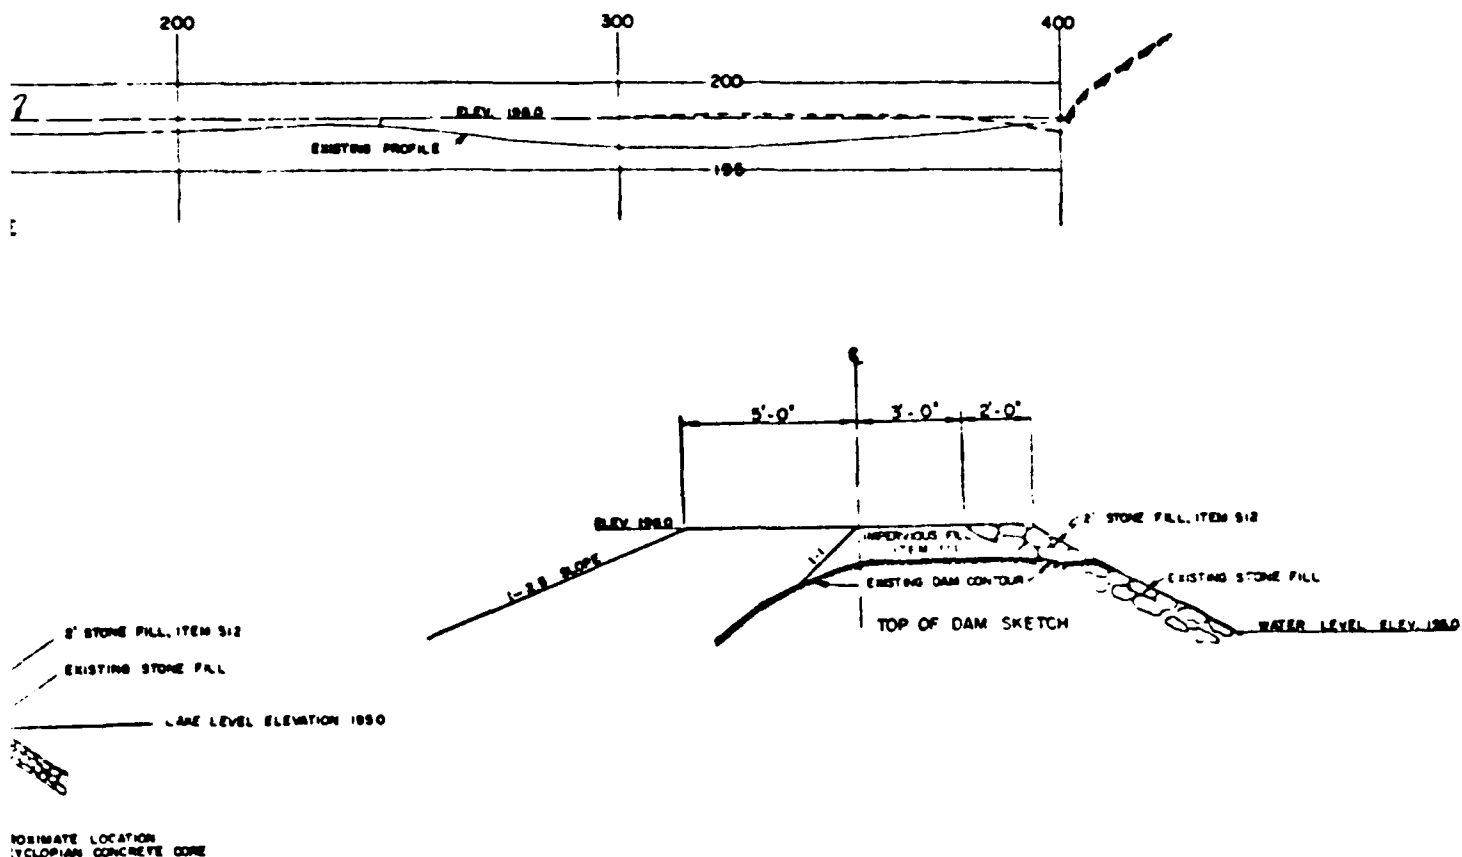
FIGURE 2

A cyclopean core wall at an approximate elevation to 1152 presumably constructed to serve as an impervious core. Thickness about 2 feet at the top and 4 feet at the bottom, see Figure 2, Appendix B. Based on the method of construction of such walls and on seepage observed downstream, it is judged that this core wall is not impervious.
